**US Army Corps
of Engineers**

USACERL Technical Report M-91/02

October 1990

Exterior Insulation and Finish Systems (EIFS) on U.S. Army Facilities: Lessons Learned

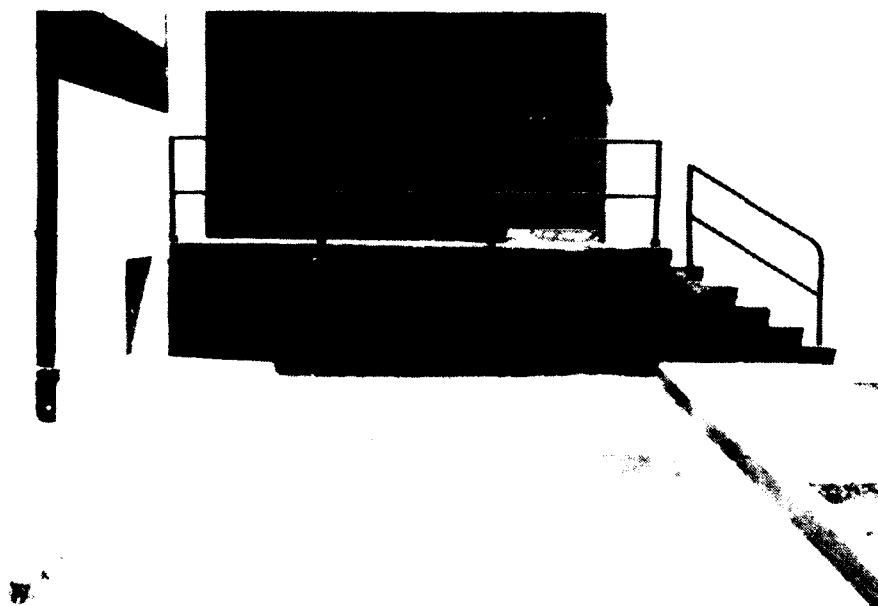
Figures 12 and 13 demonstrate that EIFS applied in loading dock areas typically had sustained extensive damage from trucks moving in and out, and the action of loading and unloading freight. This issue is discussed further in the section on design issues.

A rather broad design issue is one where systems have been applied to areas where the possibility of damage is very high. A classic example of this is applying the system to loading docks (Figures 12 and 13). With trucks backing up, forklifts moving pallets around, and other such activities, the system is extremely liable to receive impact or puncture type damage. Even the highest impact resistant EIFS cannot stand up to this kind of abuse. System alternatives should be specified for these locations.

Figure 12. Damaged EIFS around loading dock.

As recommended in the section on mechanical damage, areas prone to mechanical damage need to use high impact resistant systems. However, in loading dock areas the use of other construction materials less susceptible to mechanical damage is recommended. Such materials include solid masonry, brick, or wood paneling (wainscot). See the previous section on "Mechanical Damage - Solutions/Prevention" for further details.

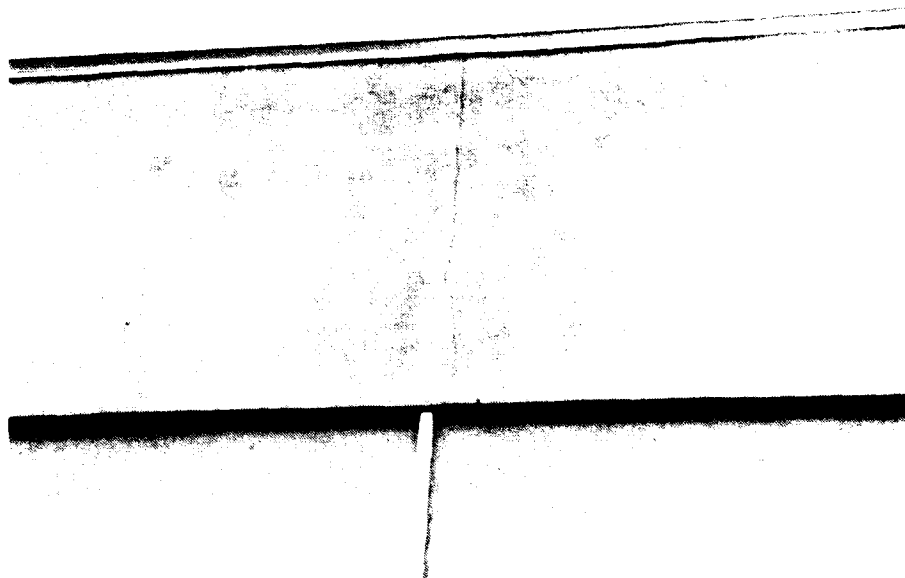
Figure 24 shows that cracks occurred along the length of the downspout due to the differences in the thermal expansion and contraction of the two material systems. At another installation, the downspouts were recessed into the system and had a spout which directed the water away from the building. In one location shown, the spout was missing and water flowed directly onto the system (Figure 25). Water will eventually erode the finish and base coat layer, increasing the potential for water penetration into the EIFS.

Figure 24. Cracking along embedded downspout.

Careful attention should be paid to the treatment of gutters and downspouts in the building design. Downspouts should not be concealed. If this is not possible, the bridge section must be isolated from the adjacent wall (Figure 27) and the downspout itself. The bridge section must not be adhesively attached to the downspout. The system and the downspout must be free to move independently of each other. Any existing installations with these conditions present will need to alter the system to conform to the above recommendations. Leaking, damaged, or missing gutters and downspouts must be repaired or replaced to reduce the possibility of water infiltration into the EIFS.

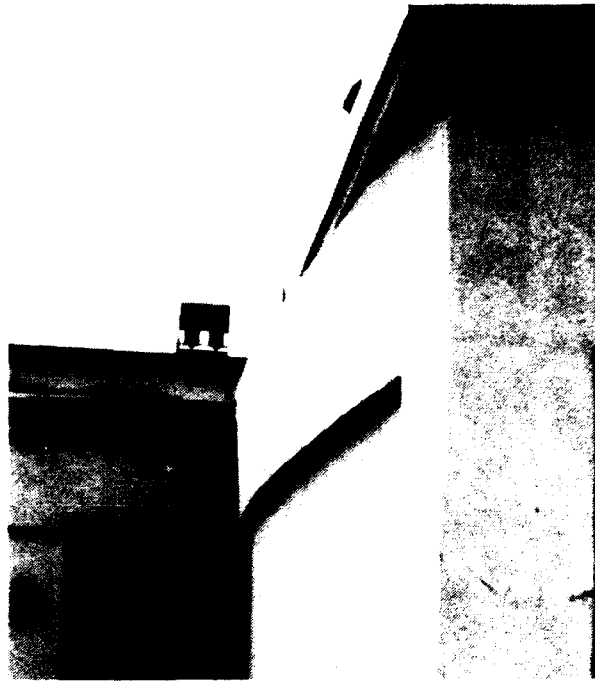
Figure 28. EIFS bowing away from substrate wall due to adhesive failure.
